FINAL - PLAN OF DEVELOPMENT BLUFF EROSION & ENHANCEMENT PROJECT

Tetra Tech, Inc. September 2000

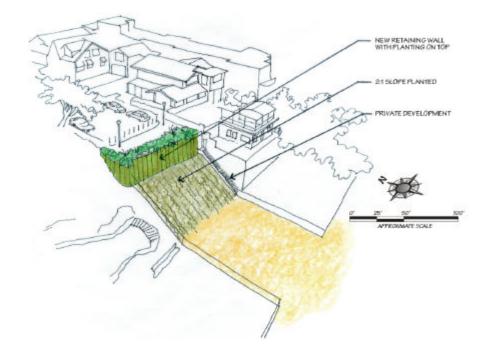
Conceptual drawing of 1st Place.

Current condition of 1st Place

The bluff area falls within the 1st Priority category. The calculated factor of safety is near 1.0 on static conditions. The slope is potentially unstable. Severe erosion is undermining the sidewalk at the end of the street.

Proposed Improvements: A reinforced slope will be engineered to stabilize the bluff while maintaining a vegetated bluff appearance. The repair of this bluff will be coordinated with the new condominium development on the east side of 1st Place. This new development will generate fill to be used for the engineered slope. The top ten feet of reinforced slope will be almost vertical with the remaining slope being 2:1 to match the existing grade on the property to the west of 1st Place. In addition, coordination with the owner of this landmark Greene & Greene designed home will be necessary for constructing the reinforced slope and consequent grading. The existing palm tree and utilities will be relocated as a result of this work.

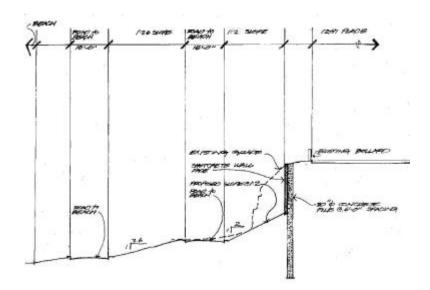
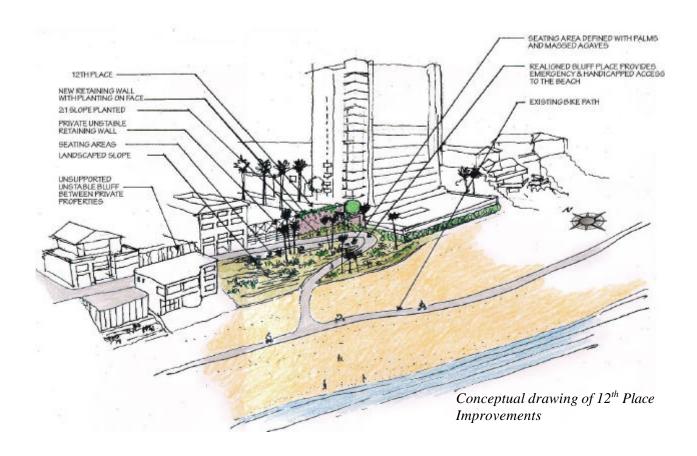
Cross section of proposed modifications

Current condition of 12th Place

Existing Issues: The City property at the end of 12th Place constitutes approximately 55 feet of the bluff and is bordered by private property on each side. The overall slope height is about 30 feet. The slope is retained by two timber walls covered by vegetation that have an overall (top to bottom) inclination of 1:1. The bluff is very steep, showing evidence of surficial failures/slumps, and it has been shored by a variety of means. A masonry retaining wall is visible along the toe of the slope. The wall appears to wrap around the eastern edge of the public right-of-way (Bluff Place) and supports grade differentials of 5 to 8 feet. Bluff Place is located along the toe of bluff and provides emergency vehicle access to the beach. There is a private retaining wall to the west that is showing evidence of failure which should be assessed as soon as possible. The two walls do not contain the entire bluff leaving the center section (area between private and public property) exposed and consequently failing.

The bluff area falls within the 1st Priority category. The calculated factor of safety within the unsupported section is near 1.0 on static conditions, which represents a potentially unstable slope.

Proposed Improvements: Due to the apparent undermining of the existing retaining walls and the adjacent private retaining wall failure, an engineered retaining structure is called for. The proposed retaining structure must be coordinated with the private property owners on the east and west. Due to the proximity of the adjacent structures, public improvements and the spatial limitations at the toe of the bluff, a near vertical retaining structure may be required. The structure will be designed to incorporate a vegetative cover to respond to the community interests. These bluff improvements will result in the realignment/regrading of existing Bluff Place, which will provide emergency vehicle and handicap access to the beach. The sloped area will be re-landscaped with palm trees, low-profile seashore plants and look-out seating areas. Utilities will be relocated and additional lighting will be provided for security.

- Replace Retaining Structure
- Coordinate with Private Property Owners
- Relandscaping and Lighting
- Utility Relocation
- Handicap Access
- Seating Areas

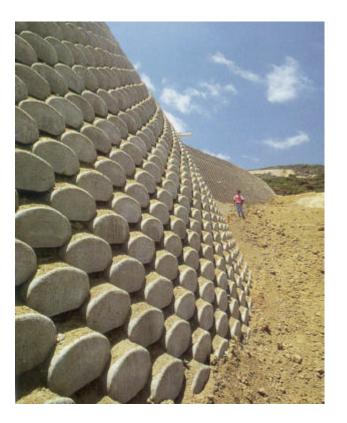
Example of modular wall.

Current condition of 8th Place

The bluff area falls within the 2nd Priority category. The bluff within public property is visually stable. However, the private improvements west of the stairway do not appear to be engineered. The calculated factor of safety is near 1.5 on static conditions, which represents a less than fully stable slope.

Proposed Improvements: Replace railroad tie walls with engineered/permitted modular block walls on west side of stairs. Regrade the slope and replant with appropriate coastal plants. Repair the existing irrigation to prevent runoff-caused erosion and improve drainage. Coordinate with private property owners for new development improvements on the east side to ensure a consistent degree of quality when slope stabilization is enlisted.

- Replace Railroad Tie Wall with Modular Block Wall
- Regrade and Revegetate Coordinate with Private Property Owners

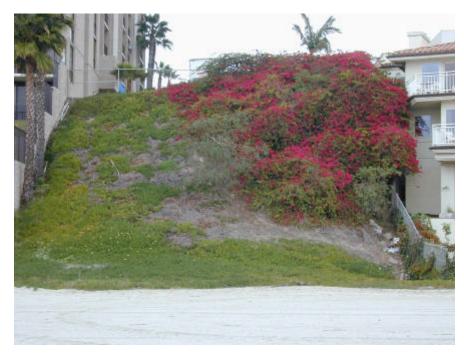
Location: Bluff at end of 13th Place

Existing Issues:

• Bluff Improvements

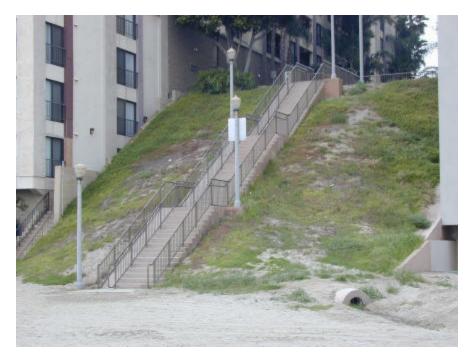
Location: Bluff at end of 14th Place

Existing Issues:

Bluff Improvements

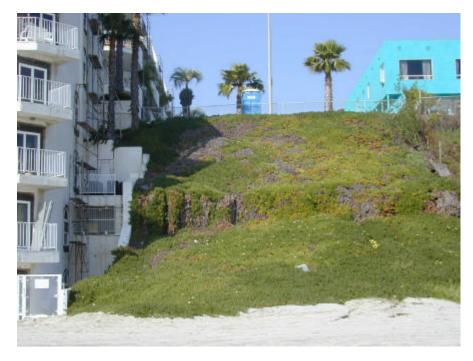
Location: Bluff at end of 15th Place

Existing Issues:

Bluff Improvements

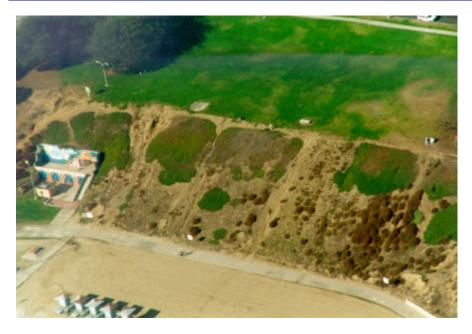
Location: Bixby Park along the top of the bluff

Existing Issues:

- Lack of Proper Pedestrian Beach Access
- Bluff Erosion

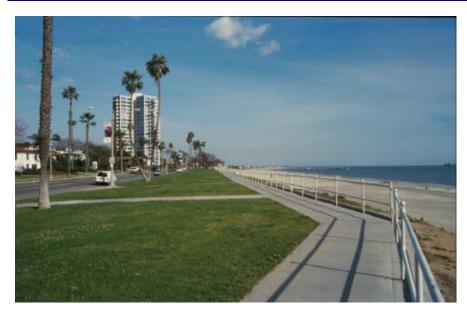
Location: Bluff Park along Ocean Boulevard

Existing Issues:

- Deteriorating Railing
- Public Safety

- Replace Railing
- Reconstruct Walkway

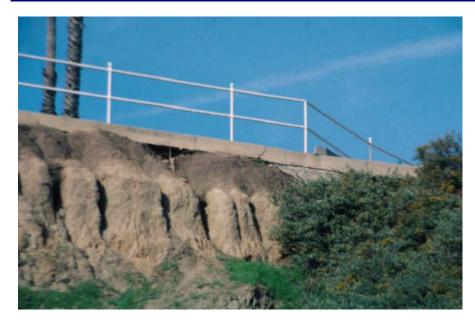
Location: Bluff Park along top of the bluff

Existing Issues:

- Subsurface Drainage
- Undermined Walkway
- Bluff Erosion

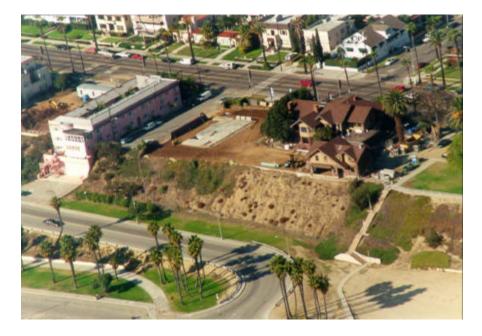
Location: Bluff Park from Museum of Art to East of Lindero Avenue along top of bluff

Existing Issues:

- Variable Sloping
- Sparse Vegetation

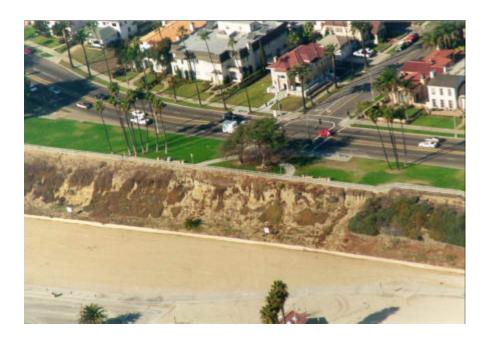
Existing Issues: This segment of bluff spans approximately 500 feet from the east edge of the Long Beach Museum of Art to the west end of the gabion-stabilized slope, east of Lindero Avenue, and falls within the 3rd Priority category. This section of bluff, which has an overall height of about 40 feet, is essentially unimproved, with variable slope inclination, slumped areas, and sparse vegetation. A buried seawall is located at the toe of slope. The average slope inclination is on the order of 1½:1, with near-vertical portions near the top and middle of the slope and generally much flatter portions near the bottom of the slope. The variable slope conditions can be attributed to subtle variations in soil layering, with the steeper portions corresponding to cohesive soil layers and flatter portions to sandy layers. The steep areas have a very uneven profile, exhibiting deep erosion and slumping.

Current condition of bluff from Long Beach Museum of Art to Lindero Avenue.

Proposed Improvements: Three methods of repairing the slope were developed. To retain the bluff's top edge, the slope can be stabilized with imported fill to reduce its current steepness. This would result in a flatter slope and would extend the toe of the slope seaward. Another alternative is to cut into the existing bluff to achieve a flatter slope, but would result in reducing the existing Bluff Park area (the community expressed concern with reducing the Park area). In order to minimize extending onto the beach and reducing the upper park area, a steep slope would be required. This could be achieved by reconstructing the slope in layers with

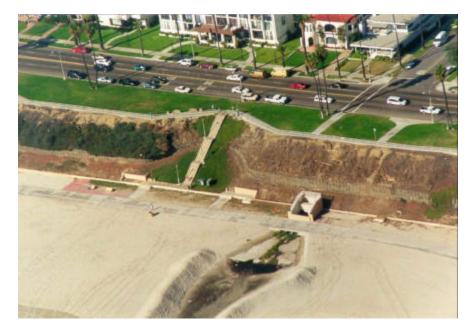
Existing Issues:

- Ongoing Demonstration Projects
- Localized erosion near walkway

Current condition of bluff from Lindero Ave. to Molino Ave. The gabion is located towards the bottom of the bluff, east of the stairs

Existing Issues: This 900-foot long segment of bluff extending up to Temple Avenue, which falls within the 2nd Priority category, has been stabilized using gabions (blocks of rocks retained by wire mesh). The gabions are located in the middle section of the slope and have a near vertical exposed face. The smooth-graded slopes above and below the gabions have average inclinations of about 2:1. A buried wall is located at the toe of slope. The slope has an overall height in the range of 36 to 38 feet and an overall average inclination of 1:1. Near the middle of this bluff segment, the slope has been flattened to 2:1 and stairs have been constructed. Vegetation above the gabions consists of shrubs. Vegetation in the slope segment below the gabions is sparse. No evidence of slope instability was noted in this segment of bluff.
